#### MULTIPLE-ARCH DAM AT GEM LAKE ON RUSH CREEK, CALIFORNIA\*

BY FRED O. DOLSON† AND WALTER L. HUBER,‡ MEMBERS, AM. SOC. C. E.

#### SYNOPSIS

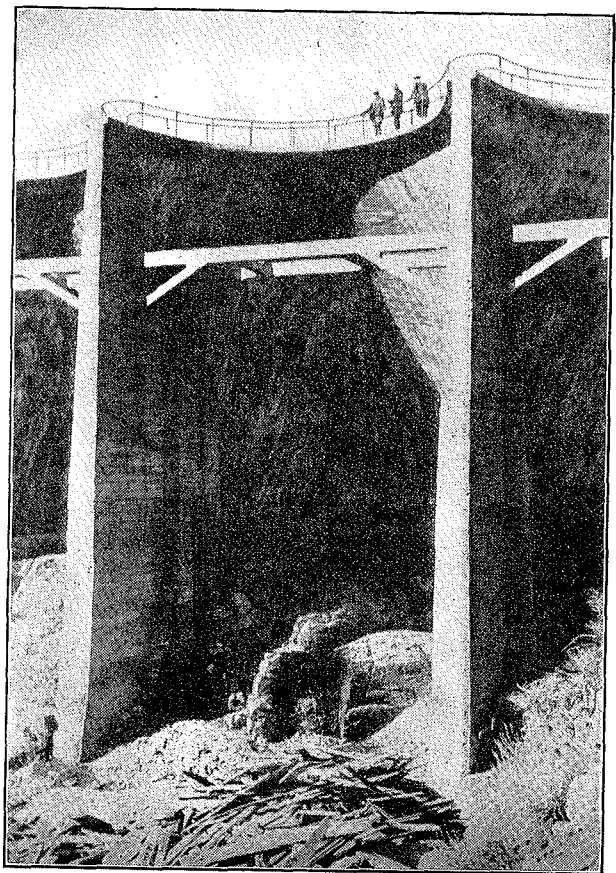
FIG. 5.—DETAILED VIEW OF REAR FACE OF ARCH NO. 3, GEM DAM.

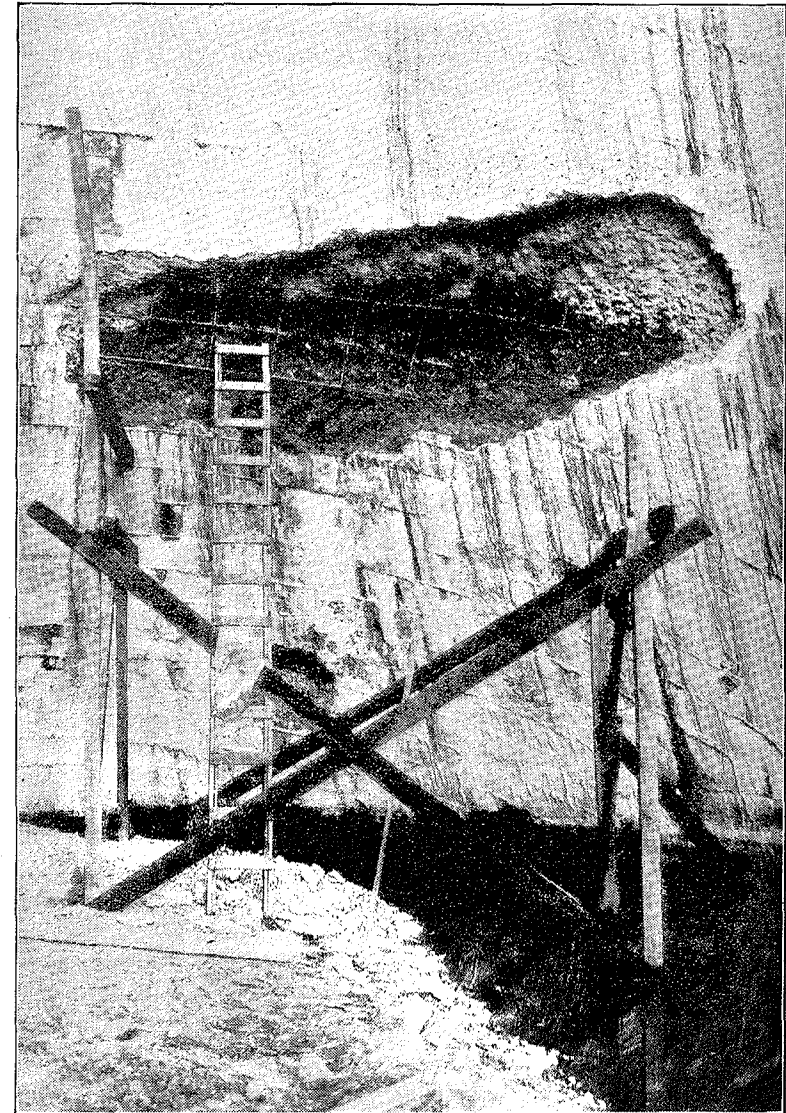
of the bottom of each arch was little affected. In the intervening middle belt, the concrete had become a dead, inert material with little strength. All concrete in the buttresses was in perfect condition.

A review of conditions convinced all the engineers who made investigations that the damage was due to water from the reservoir percolating into the concrete and there freezing. Temperatures as low as  $-25^{\circ}$  Fahr. had been recorded during winter months. A review of records showed that when extremely low temperatures had occurred, the water level, in the natural operation of the reservoir, had always been drawn down 30 ft. or more from the crest of the dam, which accounted for the good condition of the concrete in the upper portion of the arches. The flood stages of Rush Creek, which are due almost entirely to melting snow, occur in May, June, and July; consequently, the reservoir is drawn down before the low temperatures of the following winter occur. The buttresses, not being subjected to water pressure at any point, were unaffected. Those parts of the bottoms of the arches which were but little affected, were undoubtedly protected from extreme low temperatures by a snow blanket drifted against their rear faces. This conclusion is substantiated by a similar experience of The Nevada California Power Company with a simple intake dam on Bishop Creek built of thin sections which were similarly affected by low temperatures until the sections back of the concrete water face were filled with earth.

FIG. 7.—EXPLORATION IN REAR FACE OF GEM DAM EXPOSING REINFORCEMENT.

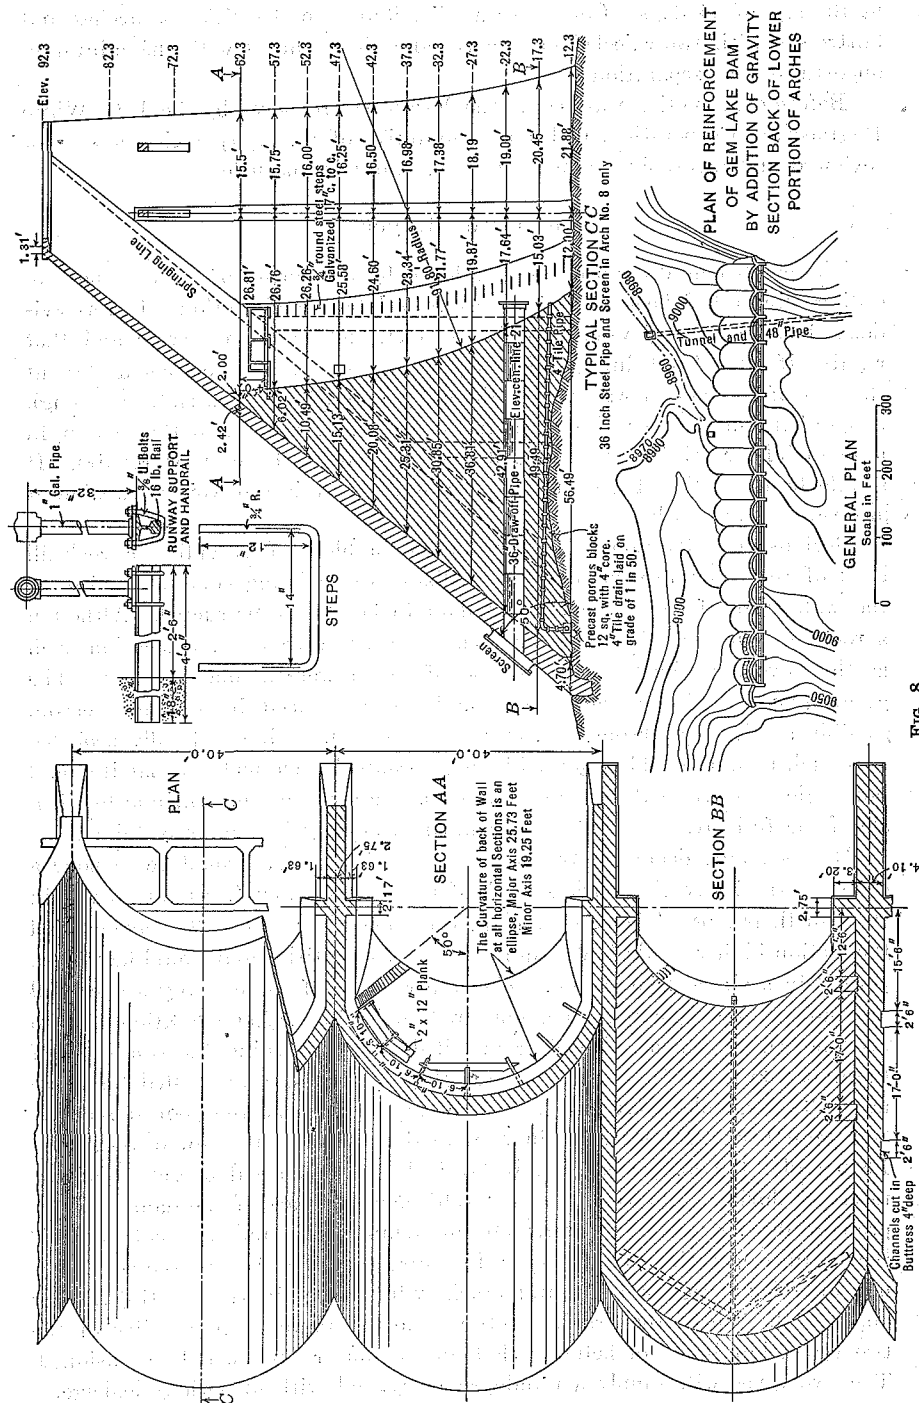
FIG. 8.

It will be noted that the section added back of the arches is not only heavier than standard profiles of gravity dams of similar height, but that, with the added pressure due to the reservoir being filled 30 ft. above the top of the gravity section, the resultant falls well within the middle third of the base, and the maximum pressure at the down-stream toe does not exceed 5 tons per sq. ft. (70 lb. per sq. in.). This is a very light pressure for the excellent hard rock foundation. In addition to the stability afforded by the gravity section, it is necessarily arched in plan, following the 40-ft. arches of the structure already existing. The section was also carried back to secure an excellent bond against the counterforts of the buttresses. It is not believed that stresses can be induced in the gravity section by pressures on the upper 30 ft. of the dam, because such pressures will be transmitted direct to the buttresses.

It was finally decided that the best method of repair would be to pour a concrete gravity section back of each of the arches, extending it up to within 30 ft. of their tops. The section adopted is shown in Fig. 8. To have carried the section higher would have required greater quantities than could have been poured in a single field season. The upper 30 ft. of the existing arches and the buttresses supporting them appeared to be in perfect condition and to need no reinforcement. To clear up all doubts concerning the condition of the upper 30 ft. of the existing arches, they were drilled and tested for hardness. Two samples were cut from what appeared to be the poorest sections and were tested for strength in compression. The tests showed results of 1 880 and 2 170 lb. per sq. in., respectively. The normal operation of the reservoir during eight years had not subjected this part of the dam to water pressure during seasons of extremely low temperature, and it is not probable that future operating conditions will require that they be so exposed. It is not improbable that a horizontal crack will develop in the existing arches opposite the top of the gravity section, due to difference in rigidity of the two types, but it is not believed that any serious results will be occasioned. The two types will simply act independently and without serious leakage.

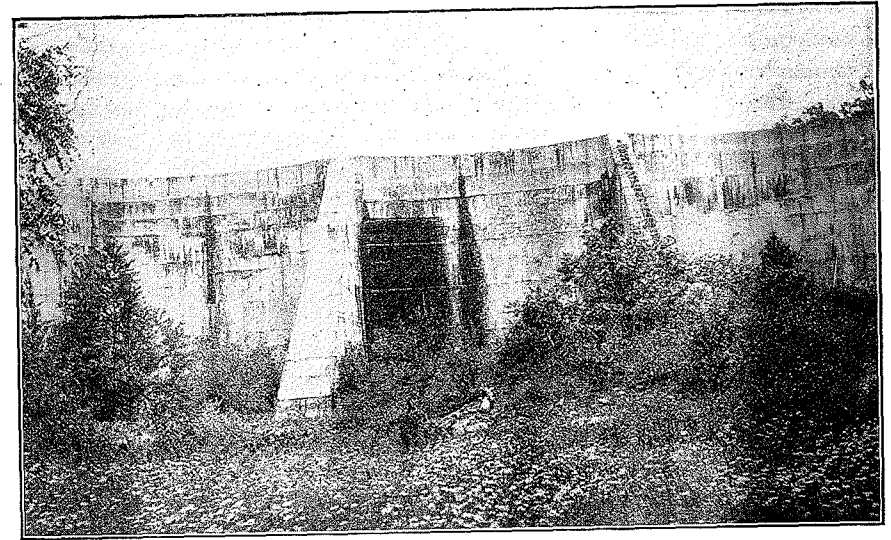
FIG. 12.—MULTIPLE-ARCH DAM IN CENTRAL NEW YORK, DOWN-STREAM FACE, SHOWING DISINTEGRATION.

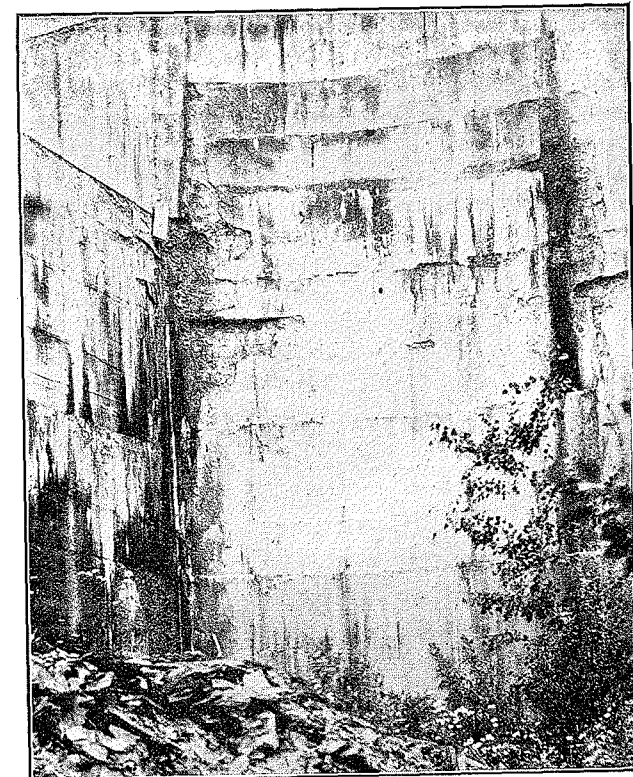
FIG. 13.—DETAIL OF DOWN-STREAM FACE, MULTIPLE-ARCH DAM (LEFT BAY IN FIG. 12), SHOWING EXTENT OF SPALLING.
