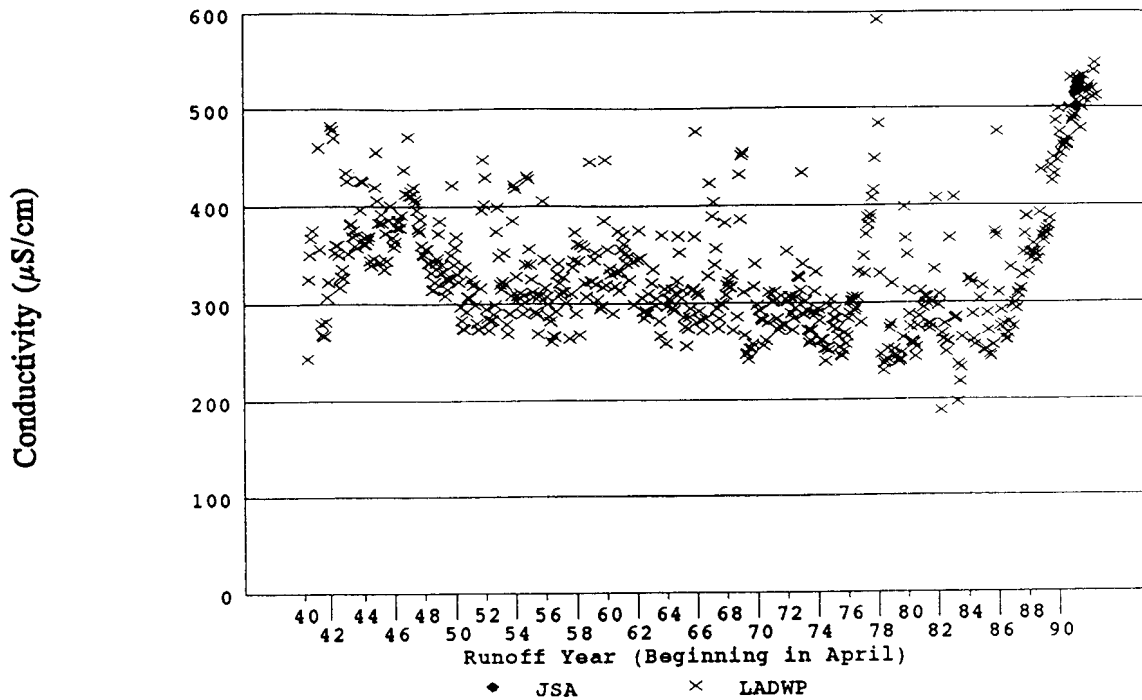
Figure 3B-6.
Crowley Lake Outlet Conductivity, 1940-1991
