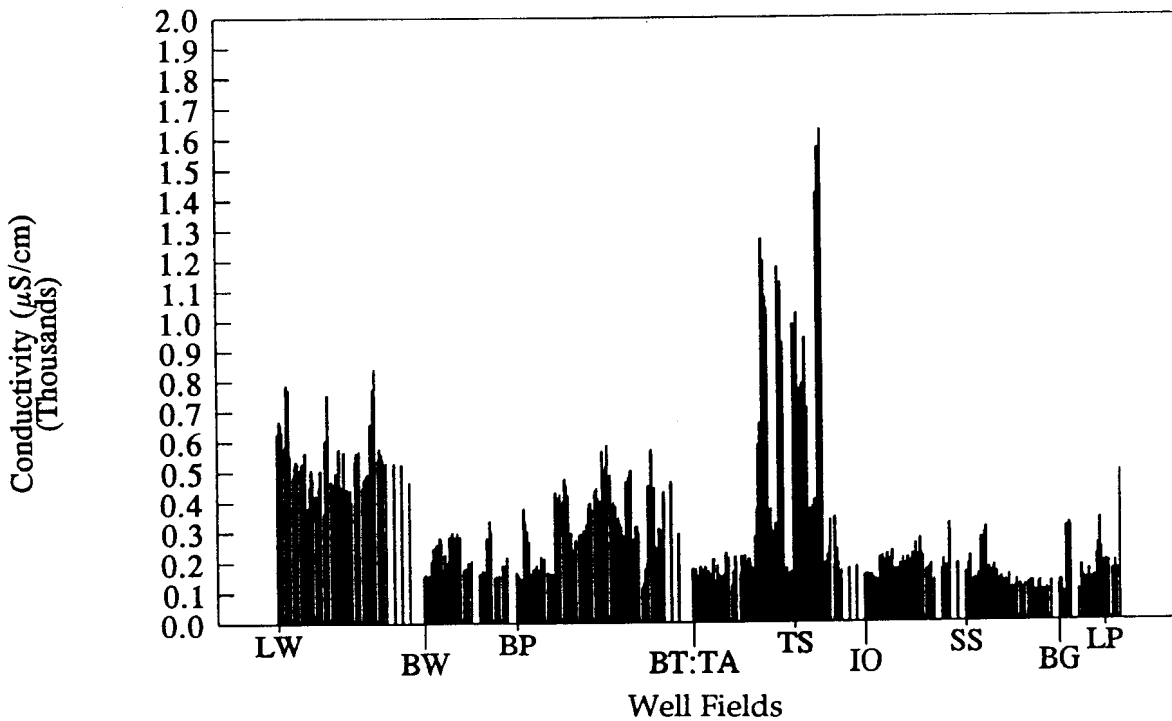
Figure 3B-7.
Conductivity of LADWP Well Water in the Owens River Basin

Note: See text for well field names.
